PCM2.1 & BOSE Amplifier Spare Parts Requirements

Section - 9, Electrical System. This bulletin replaces bulletin, Group 9, 7/04, dated 4-26-05.

Vehicle Type: 911 Carrera (997)/911 Carrera S (997)

Model Year: 2005 (5)

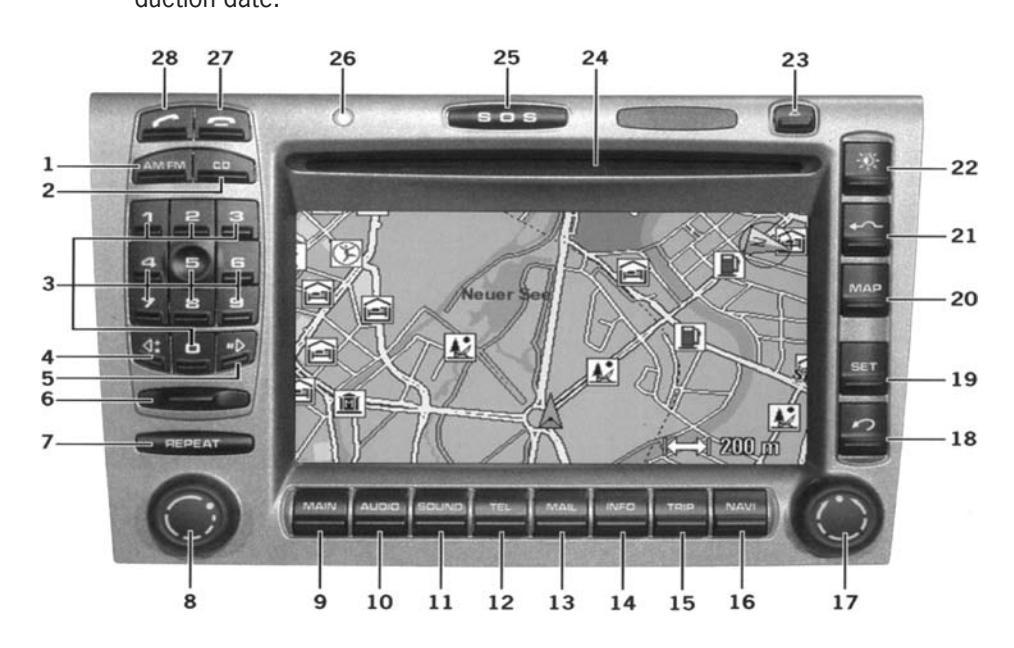
- **1.** To display the current software version of the PCM2.1 in the display of the PCM2.1 control part:
 - If necessary, switch on the PCM2.1 by pressing the "On/Off switch" (Fig. 1, Item 8). After switching on the PCM2.1, simultaneously press the "MAIN" and "TRIP button" (Figure 1, Item 9 and Item 15) to go to the display "SW versions".
 - Select the menu item "PCM" in the display "SW versions" by turning the rotary knob (Figure 1, Item 17).
 - Depending on the software version of the PCM2.1, the following version is shown in the display: 04035AD1: The software matches the PCM2.1 version for vehicles from M.Y. 05 up to the introduction date.
 - 04202JD1: The software matches the PCM2.1 version for vehicles from M.Y. 05 as of the introduction date.

- **2.** Displaying the current software version of the BOSE amplifier in the display of the PCM2.1 control part.
 - Select the menu item "Amplifier" in the display "SW versions" by turning the rotary knob (Figure 1, Item 17).
 - Depending on the software version of the amplifier, the following version is shown in the display: 00016400 or 00016401: The software matches the amplifier software version for vehicles from M.Y. 05 up to the introduction date.
 - 00017500: The software matches the amplifier version for vehicles from MY 05 as of the introduction date.
 - Press the "Back button" (Fig. 1, Item 18) to return to the PCM2.1 Start menu.
