Technical Information

Cayenne
11/04 E 6963 **6**

Airbag warning light activated:

Diagnostic trouble code 1217 and/or 1218 in airbag control unit fault memory

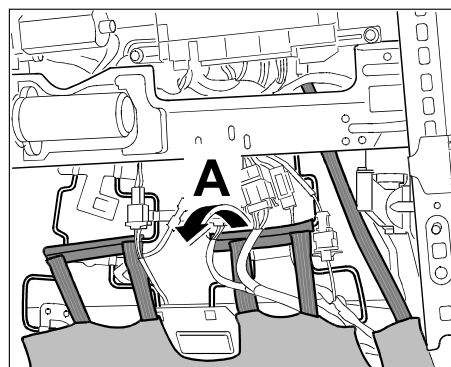
Bild...Figure...ill...figura...fig 1

- 2.1 Disengage the right tensioning strap of the backrest cover (Figure 1, arrow A).

- 4.3 Clip in the modified wire harness on the connector bracket (= position of previous side airbag plug connection) and tighten to the seat suspension with a tie-wrap.
- 4.4 Engage the right tensioning strap of the backrest cover (Figure 6, arrow A).

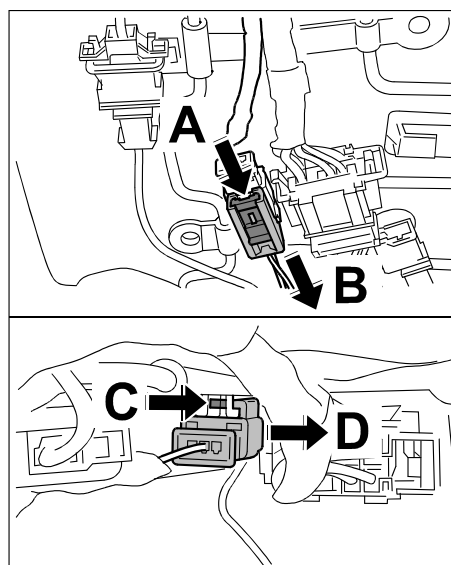
Bild...Figure...ill...figura...fig 2

- 2.2 Slide back locking mechanism of side airbag connector (Figure 2, arrow A) and pull out of the socket of side airbag (arrow B).
- 2.3 Then release side airbag connector on seat frame (arrow C) and push out towards the front (arrow D).

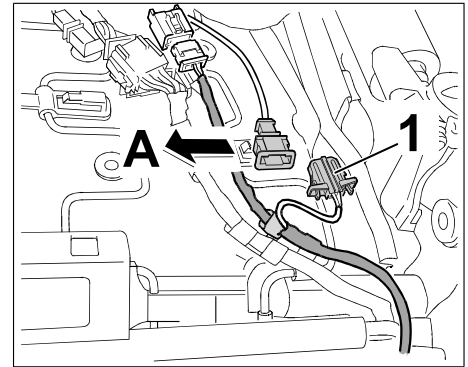
Bild...Figure...ill...figura...fig 3

2.5 Release connector of ground strap from side airbag (Figure 3, Item 1) and pull out of the socket.

2.6 Release the connector bracket on the rear seat suspension and pull off socket of the ground strap (arrow A).

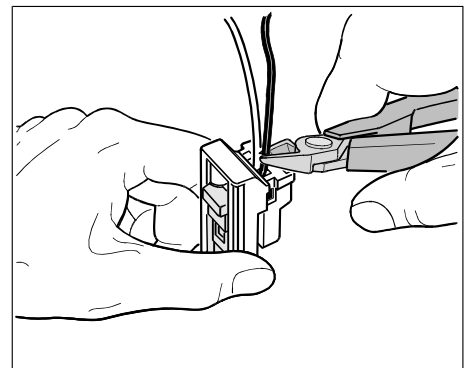
Bild...Figure...ill...figura...fig 4

3.1 Position both lines of the control unit-sided wire harness flush on the connector and cut through them **individually** (Figure 4).

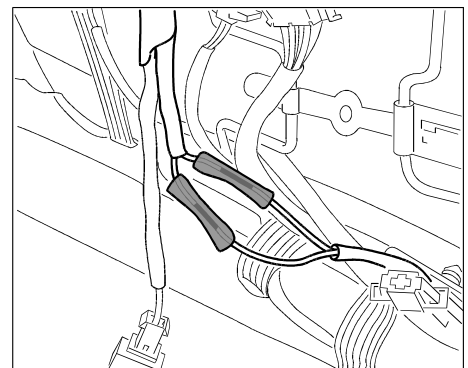
Bild...Figure...ill...figura...fig 5

3.6 Position each shrink-fit hose over the cable connection and shrink-fit with a hot-air gun (Figure 5).

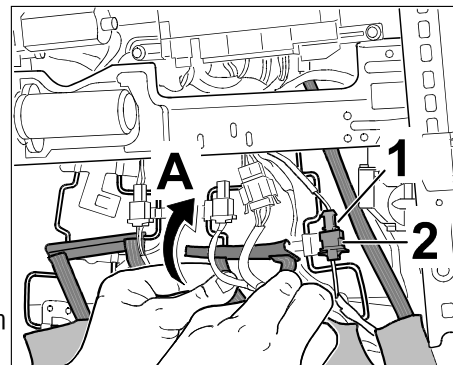
Bild...Figure...ill...figura...fig 6

- 4.1 Wrap the unwound chafing prevention tape on the modified wire harness around and over the cable connection position.
Complete the modified wire harness with cloth adhesive tape or commercially available insulating tape.
- 4.2 Clip in the socket of ground strap (Figure 6, Item 1) in the connector bracket of the rear seat suspension and connect with connector of side airbag ground strap (Item 2).
